# 1970-71 Fairlane/Torino Corner

## Hideaway Headlight Vacuum System Schematic

## Hideaway Headlight Vacuum Leak Repair Procedure

by Bill Shenk (with supplemental info from Tim Zagata)

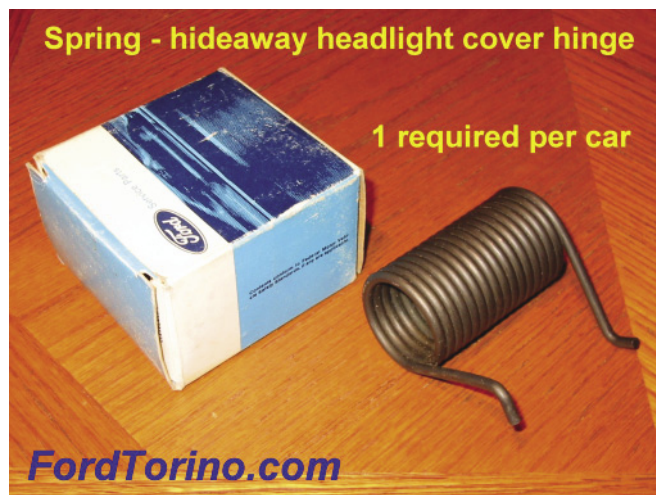
This spring opens the headlight covers in the event of a vacuum failure. It is located near the vacuum motor. See illustration on facing page.

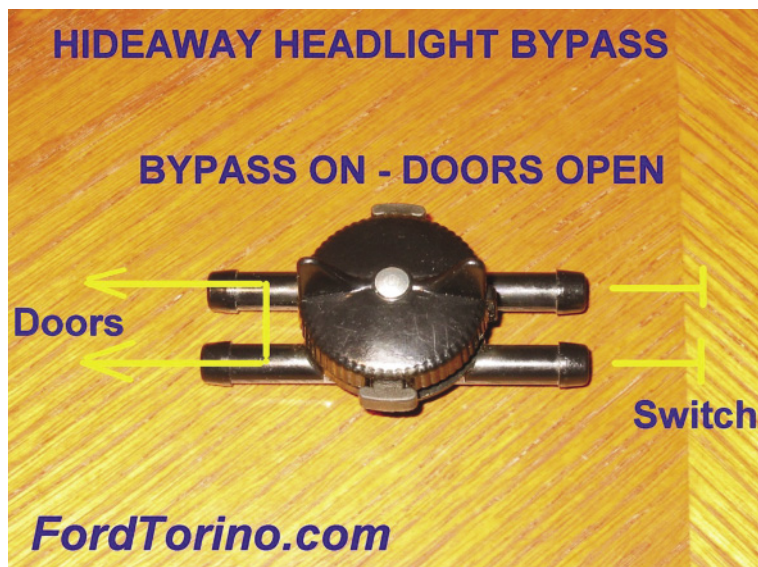
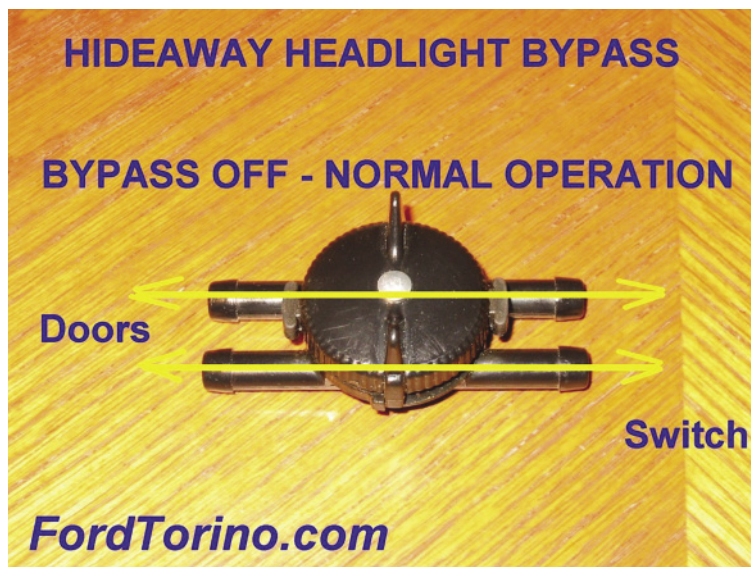
When this valve (located near the driver's side shock tower) is in the "bypass" position, it closes off each port on the switch side of the valve. This cuts off the vacuum source to the headlight door actuator motor.

It also allows vacuum to flow between the two ports on the headlight door side of the valve. This is where the spring (see photo at top of page) comes into play. Since vacuum is allowed to flow through both ports of the door side of the bypass valve, that allows the actuator motor to move freely either up or down. The tension from the spring forces the actuator motor arm to keep the headlight doors open. This is useful when cleaning or changing a headlight bulb. Or when icy weather is expected, the bypass valve can be used so that the headlight doors will always remain open and not be frozen in the closed position when your headlights are required.

Replace the Bypass Valve (F) with another spare (new) valve. Turn the top of the valve perpendicular to the hoses. Reconnect both green and yellow hoses to the new valve.
